**Flood Control Project Maintenance  
Levee Inspections**

**Fall 2013 Levee Maintenance Deficiency Summary Report**

**Flood Control Project Maintenance  
Levee Inspections  
LMA District Cover Sheet  
Fall 2013 Levee Inspection Results**

**Reclamation District No. 0003 Grand Island**

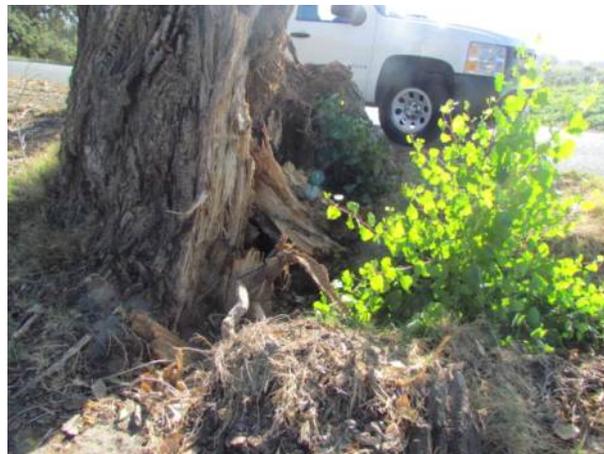
Levee Mile Report Line	5
Start Levee Mile	0.14
End Levee Mile	0.14
Location	Water Side
Category	Earthen Levee
Item	Encroachments
Looking south at tree branches on waterward shoulder.	
richard_f_20131003_047.JPG

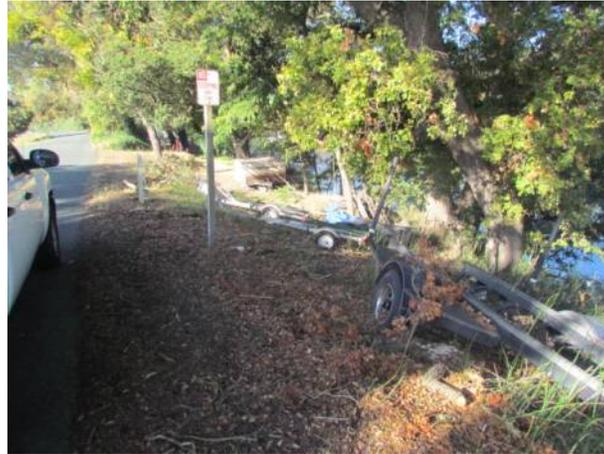
Levee Mile Report Line	8
Start Levee Mile	0.22
End Levee Mile	0.33
Location	Water Side
Category	Earthen Levee
Item	Vegetation
Looking southwest at landscaping on waterside shoulder and slope.	
richard_f_20130918_077.jpg

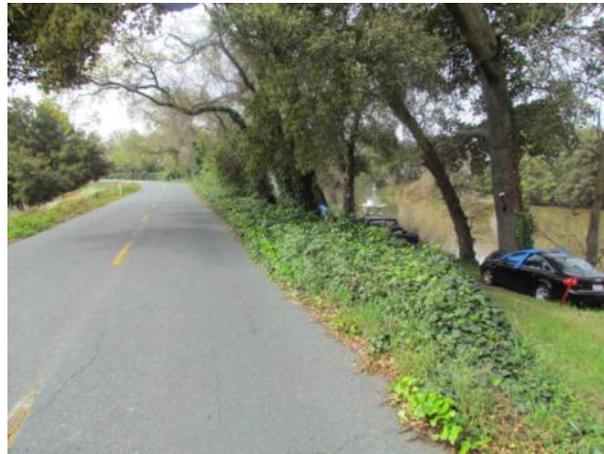
Levee Mile Report Line	10
Start Levee Mile	0.46
End Levee Mile	0.46
Location	Land Side
Category	Earthen Levee
Item	Vegetation
Looking southeast at century plant on landside shoulder.	
richard_f_20130918_092.JPG

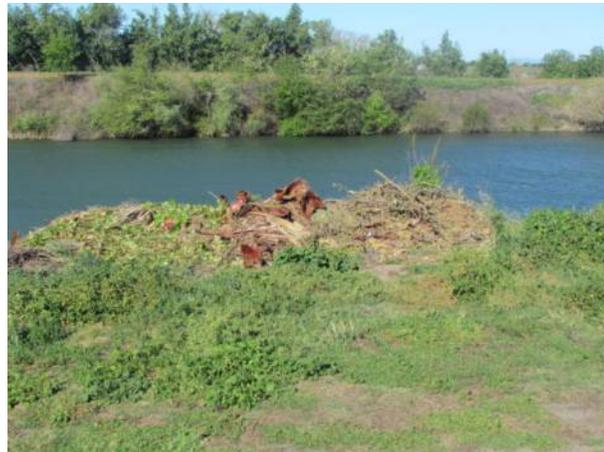
LMR No.	Levee Mile		Category	Item	Location	Rating	Action/Comment	GPS Latitude/Longitude		Issue No. Photo
	Start	End						Start	End	
36	2.60	2.60	Earthen Levee	Encroachments	WS Ma	M	TR : Tree or limb Inspector Comments: Broken tree limbs on waterward shoulder.	°	°	13 Y
DWR ID: DWR_RD0003_01_f_2013_13										
37	2.70	2.70	Earthen Levee	Encroachments	WS Ma	M	TR : Tree or limb Inspector Comments: Broken tree limb on waterward slope.	38.270768 ° -121.588663 °	38.270768 ° -121.588663 °	38
DWR ID: DWR_RD0003_01_s_2013_38										
38	2.83	2.83	Earthen Levee	Vegetation	LS En	M	V6 : Landscaping	38.268844 ° -121.588264 °	38.268844 ° -121.588264 °	41
DWR ID: DWR_RD0003_01_s_2012_41										
39	2.89	2.89	Earthen Levee	Encroachments	WS En	U	BU : Building Inspector Comments: Storage shed has been here for several years on waterward berm. Storage shed is appears to be abandoned and should be removed.	38.268257 ° -121.587677 °	38.268257 ° -121.587677 °	48 Y

Levee Mile Report Line	36
Start Levee Mile	2.60
End Levee Mile	2.60
Location	Water Side
Category	Earthen Levee
Item	Encroachments
Looking southwest at broken tree limbs on waterward shoulder and slope.	
richard_f_20131003_049.JPG

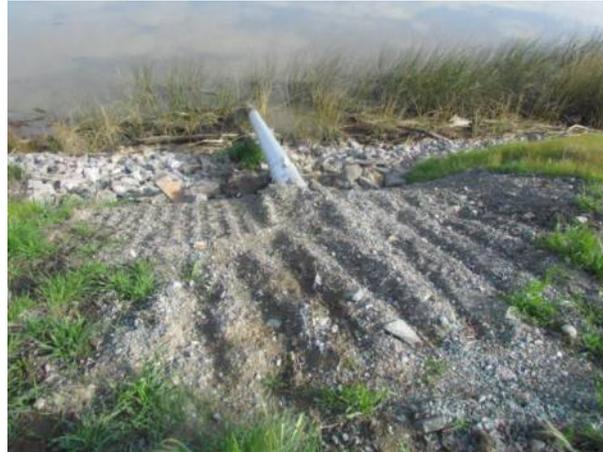
Levee Mile Report Line	100
Start Levee Mile	9.19
End Levee Mile	9.19
Location	Water Side
Category	Earthen Levee
Item	Encroachments
Pipe penetration showing newer pipe next to abandoned pipe.	
richard_f_20130918_129.jpg

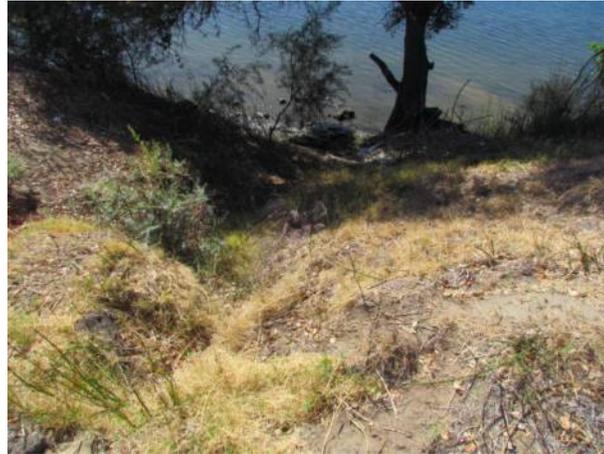
Levee Mile Report Line	10
Start Levee Mile	0.40
End Levee Mile	0.40
Location	Water Side
Category	Earthen Levee
Item	Slope Stability

Slope instability caused by foot traffic on levee slope.

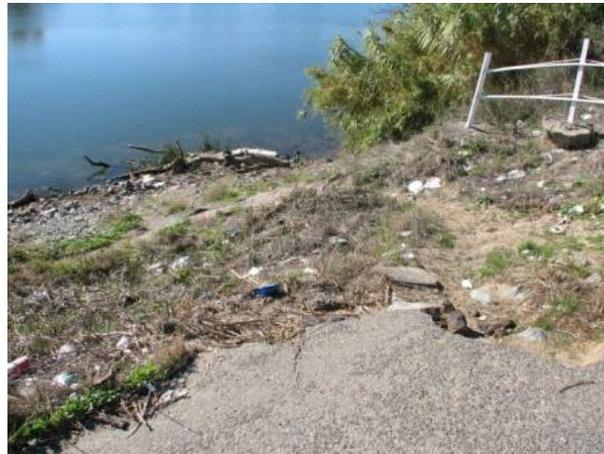
Levee Mile Report Line	10
Start Levee Mile	0.40
End Levee Mile	0.40
Location	Water Side
Category	Earthen Levee
Item	Slope Stability

Looking east at repaired slope damage caused by foot traffic.
